FLOOD PLAIN INFORMATION

CHITTENANGO CREEK,

BRIDGEPORT,

CORPS OF ENGINEERS, U. S. ARMY
BUFFALO DISTRICT

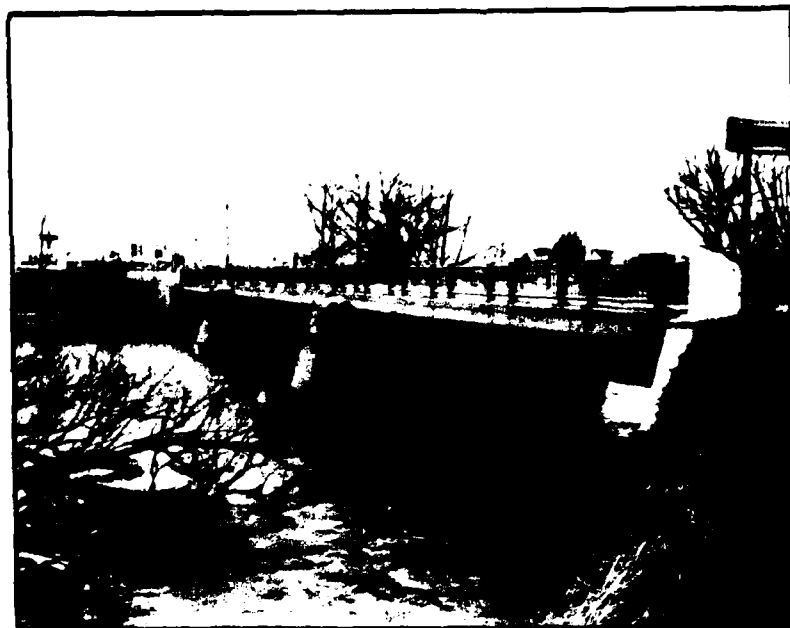
Figure 3 - Looking at upstream face of N.Y.S.
Route 31 bridge.

BRIDGES ACROSS THE STREAM - There are two highway bridges which cross Chittenango Creek in the reach covered by this study. Table 2 lists pertinent data for these structures and the relationship of the Intermediate Regional and the Standard Project Floods to the March 1964 flood. The two bridges are shown in figures 3 and 4.

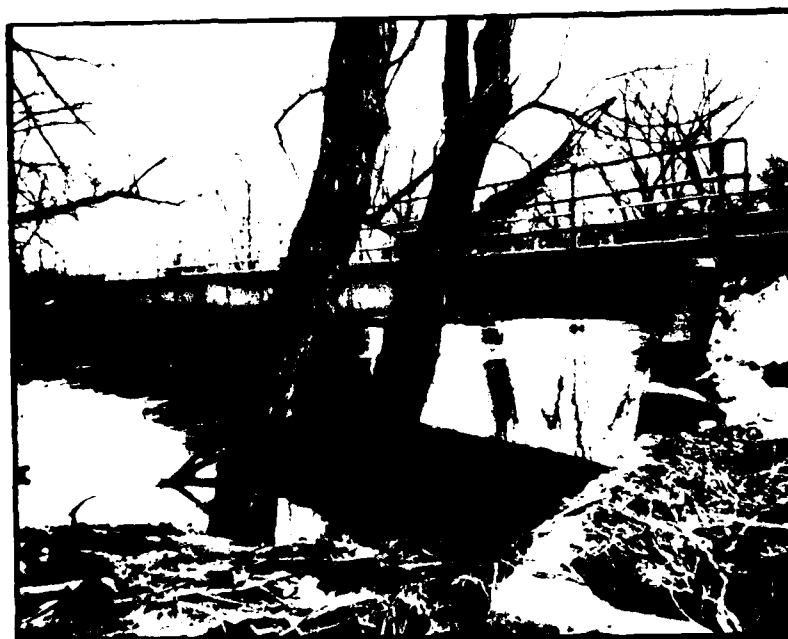
Figure 4 - Oxbow Road bridge.

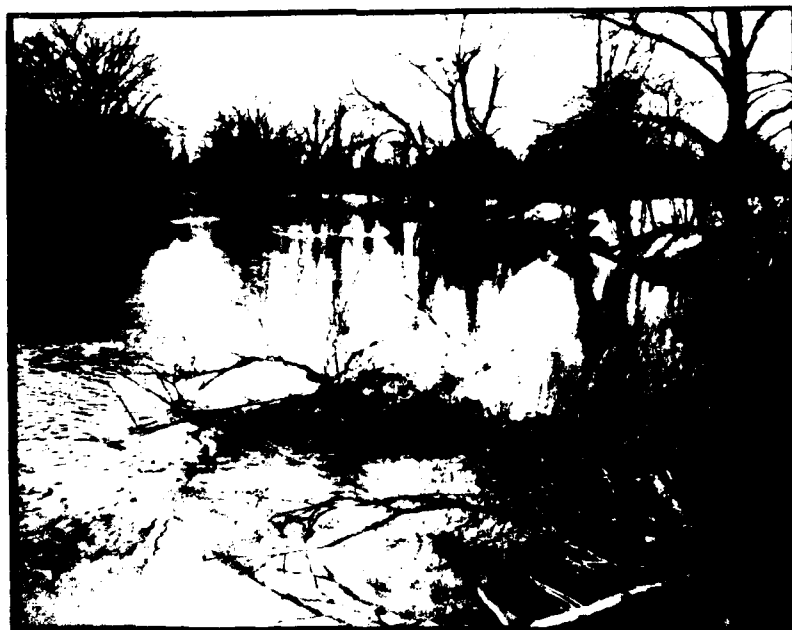
Figure 6 - Looking downstream from Sxbow Road at
growth in channel.

OBSTRUCTIONS TO FLOOD FLOWS - When debris collects at the upstream side of bridges, flows are severely retarded. Chittenango Creek in the study area has a relatively flat gradient and has a congested meandering channel of low capacity. A natural rock weir in the channel of Chittenango Creek, near Bridgeport, causes backwater flooding of Cicero Swamp during low flood flows but has little effect on the higher flows. Figures 5 and 6 show growth in the channel which could significantly reduce the amount of flow as a result of collecting debris.

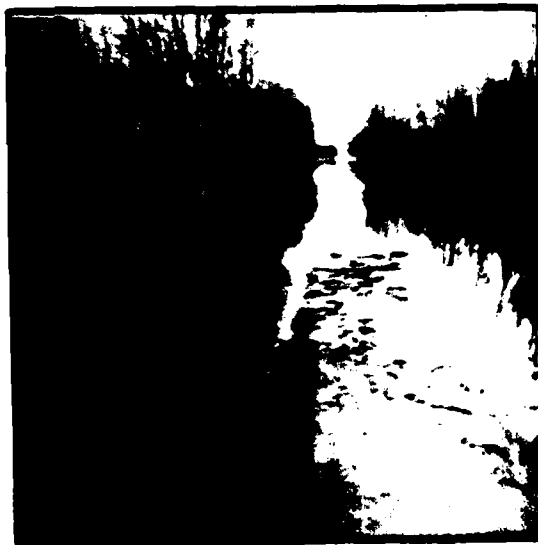
Figure 8 - Looking south along N.Y.S. Route 298 within the Cicero Game Management Area. March 1964 flood.

MARCH 1964 - A low pressure system in the Mississippi Valley produced a cold front that began moving toward Syracuse. At the same time, warm moist air began moving up from the Gulf of Mexico. These two systems clashed over the plains of southern Illinois. The low pressure deepened and with it came wind and rain. In the Syracuse area the temperature rose into the 60's and was accompanied by 60-mile per hour winds. This combination caused considerable flooding within the study area. Figures 7-10 show flooding conditions that occurred in March 1964.

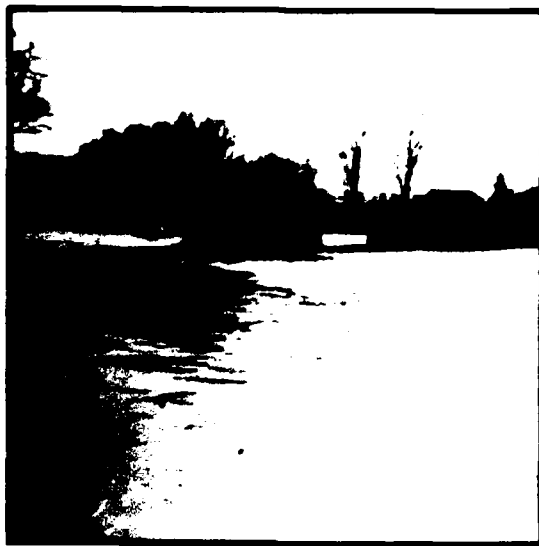
Figure 9 - Looking north at upstream face of N.Y.S. Route 31 bridge in Bridgeport. March 1964 flood.

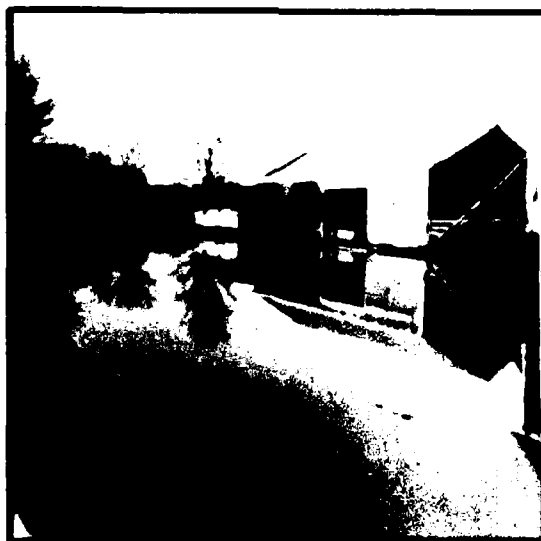
Figure 10 - View of farm located approximately at stream mile 7.5. March 1964 flood.

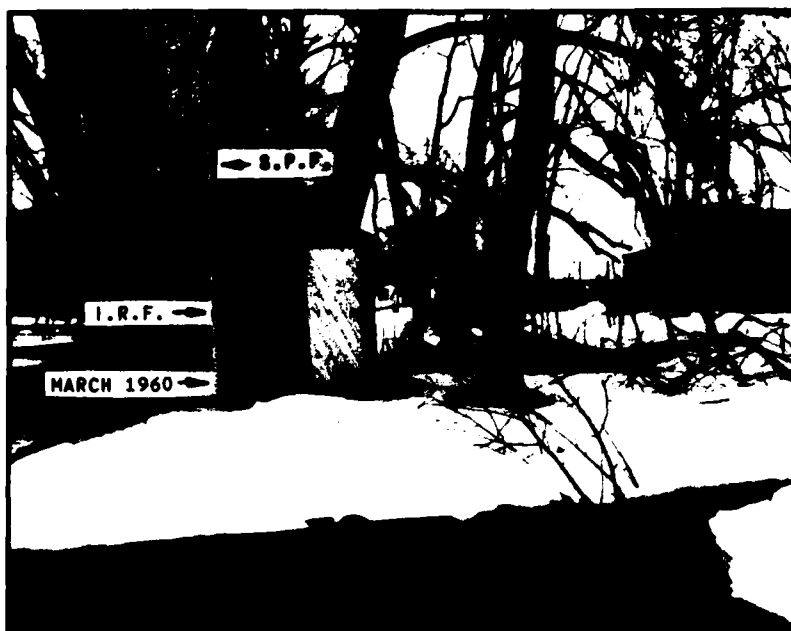
Figure 12 - Arrows indicate the heights of the Standard Project, Intermediate Regional, and March 1960 floods, stream mile 0.5.

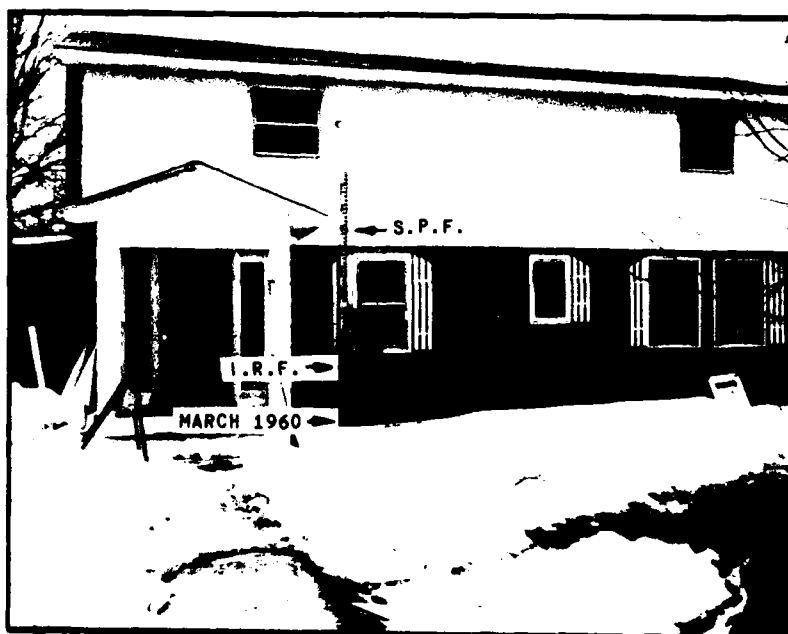
Figure 13 - Arrows indicate the heights of the Standard Project, Intermediate Regional, and March 1960 floods at residence on Hitchcock Road, stream mile 1.8.

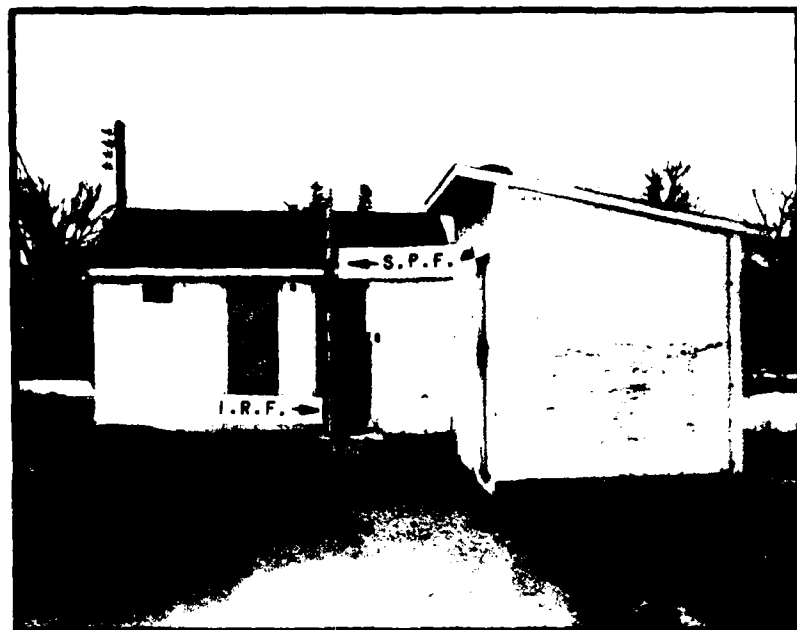
Figure 14 - Arrows indicate the heights of the Standard Project and Intermediate Regional floods at pumphouse just downstream of N.Y.S. Route 31, stream mile 3.4.

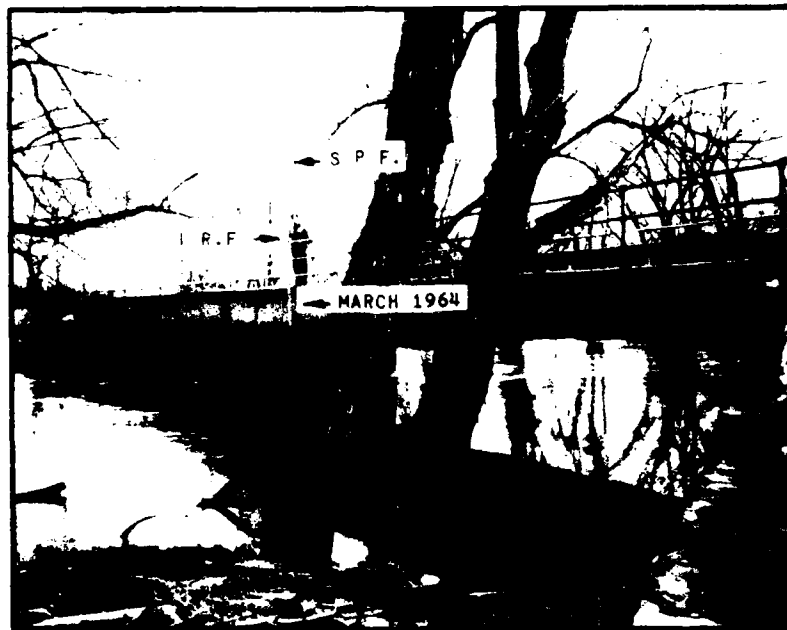
Figure 17 - Arrows indicate the heights of the Standard Project, Intermediate Regional, and March 1964 floods at the upstream side of Oxbow Road bridge, stream mile 7.04.
